LOWER BUCKS COUNTY JOINT MUNICIPAL AUTHORITY

ATTACHMENT A

STANDARD VENT AND CLEANOUT ARRANGEMENT

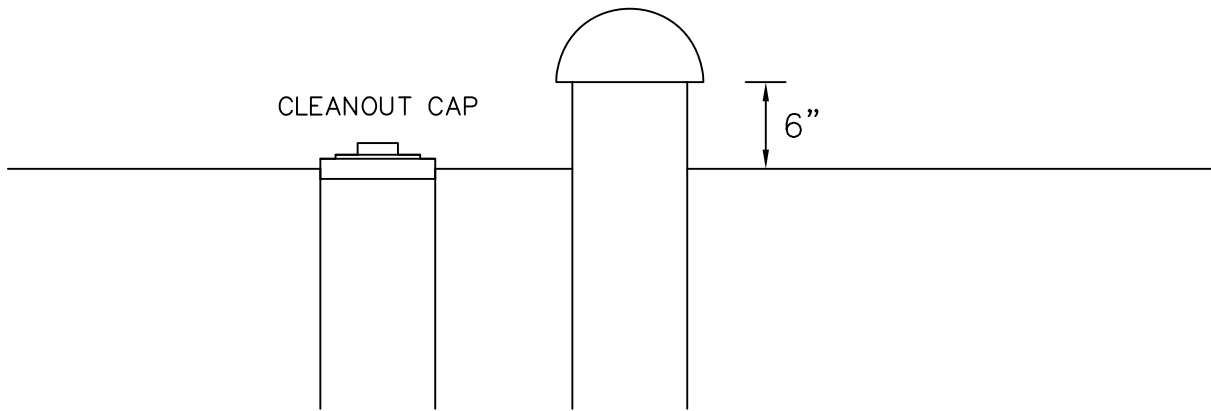
VENT W/ MUSHROOM CAP

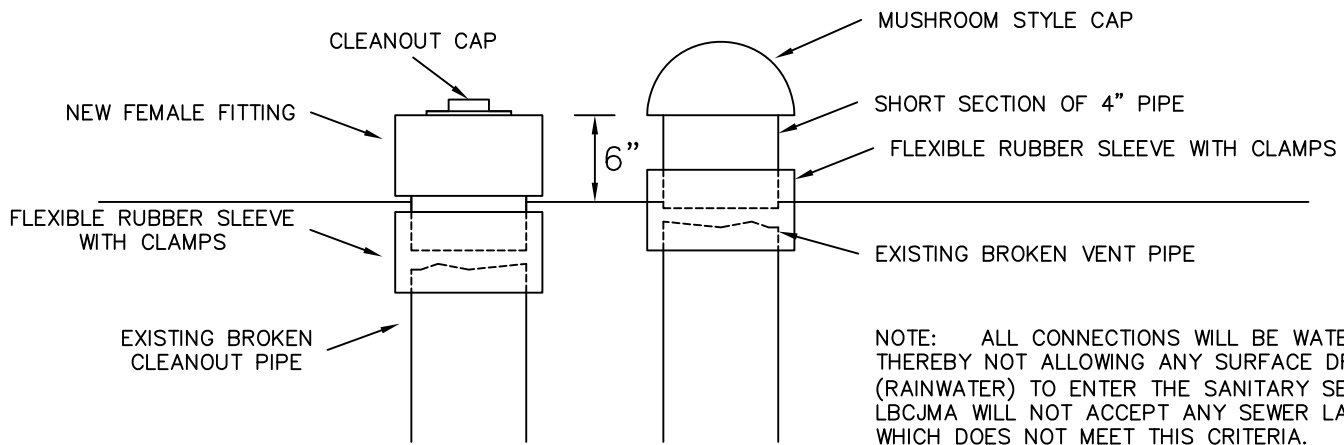
ACCEPTABLE REPAIR FOR BROKEN VENT AND/OR CLEANOUT

NOTE: ALL CONNECTIONS WILL BE WATERTIGHT THEREBY NOT ALLOWING ANY SURFACE DRAINAGE (RAINWATER) TO ENTER THE SANITARY SEWER. LBCJMA WILL NOT ACCEPT ANY SEWER LATERAL WHICH DOES NOT MEET THIS CRITERIA.
